TECHNICAL REPORT GL-87-14

SEISMIC STABILITY EVALUATION OF FOLSOM DAM AND RESERVOIR PROJECT

Report 3 CONCRETE GRAVITY DAM

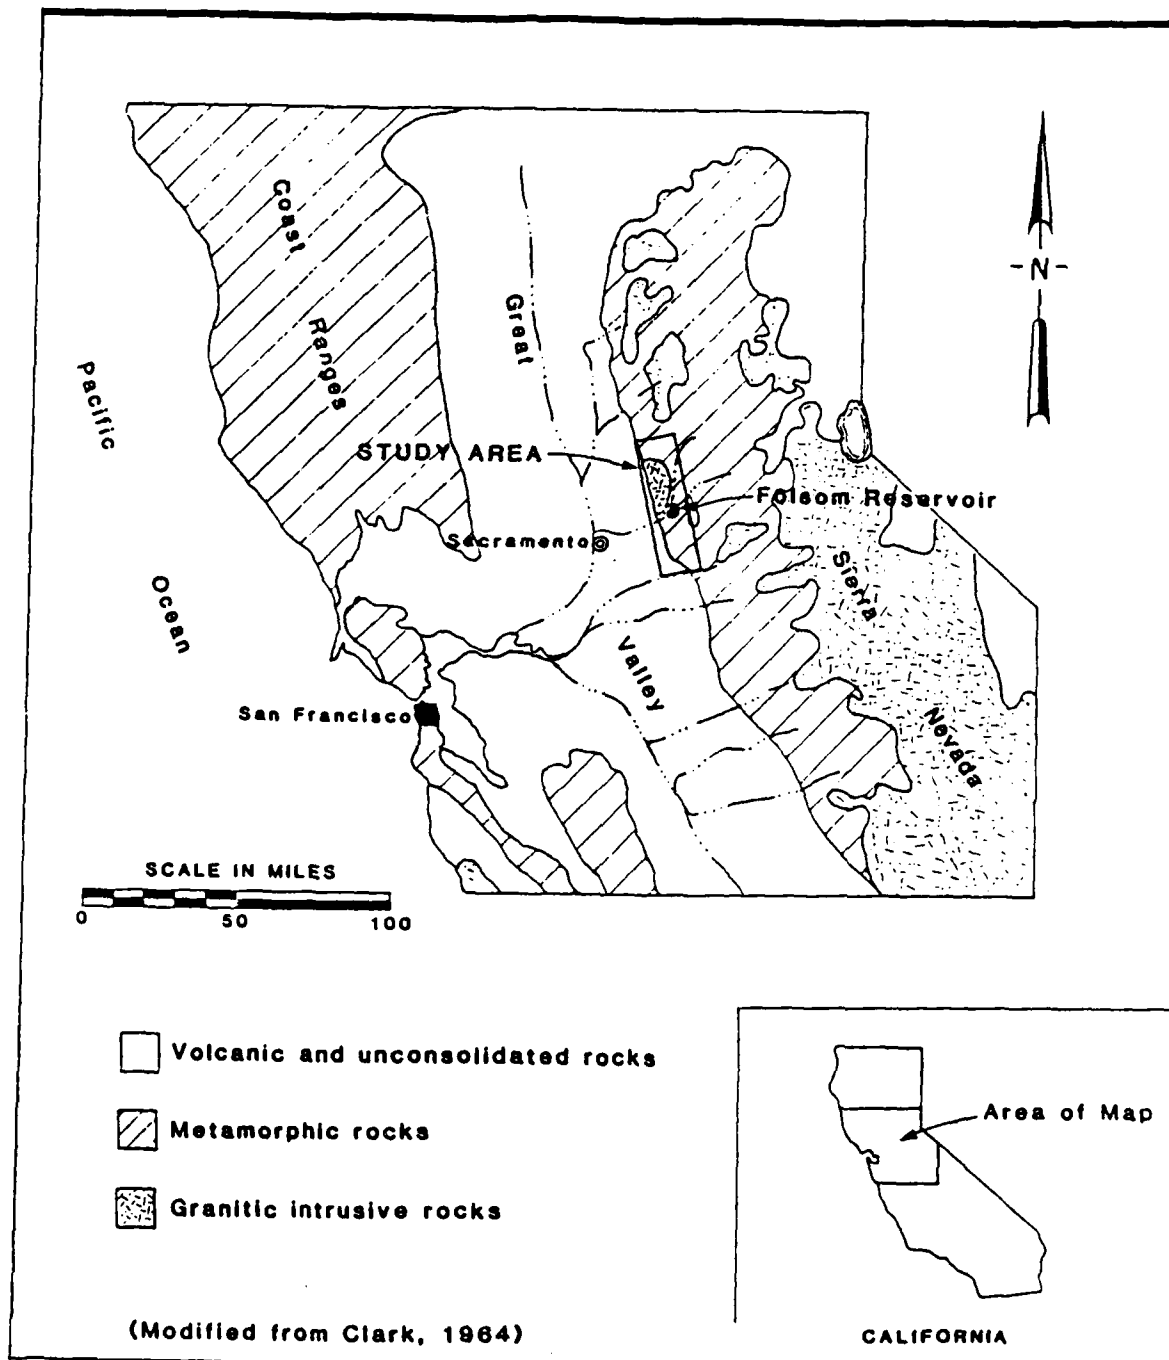
Figure 2. Seismological study area

Prepared by Terra Engineering Consultants

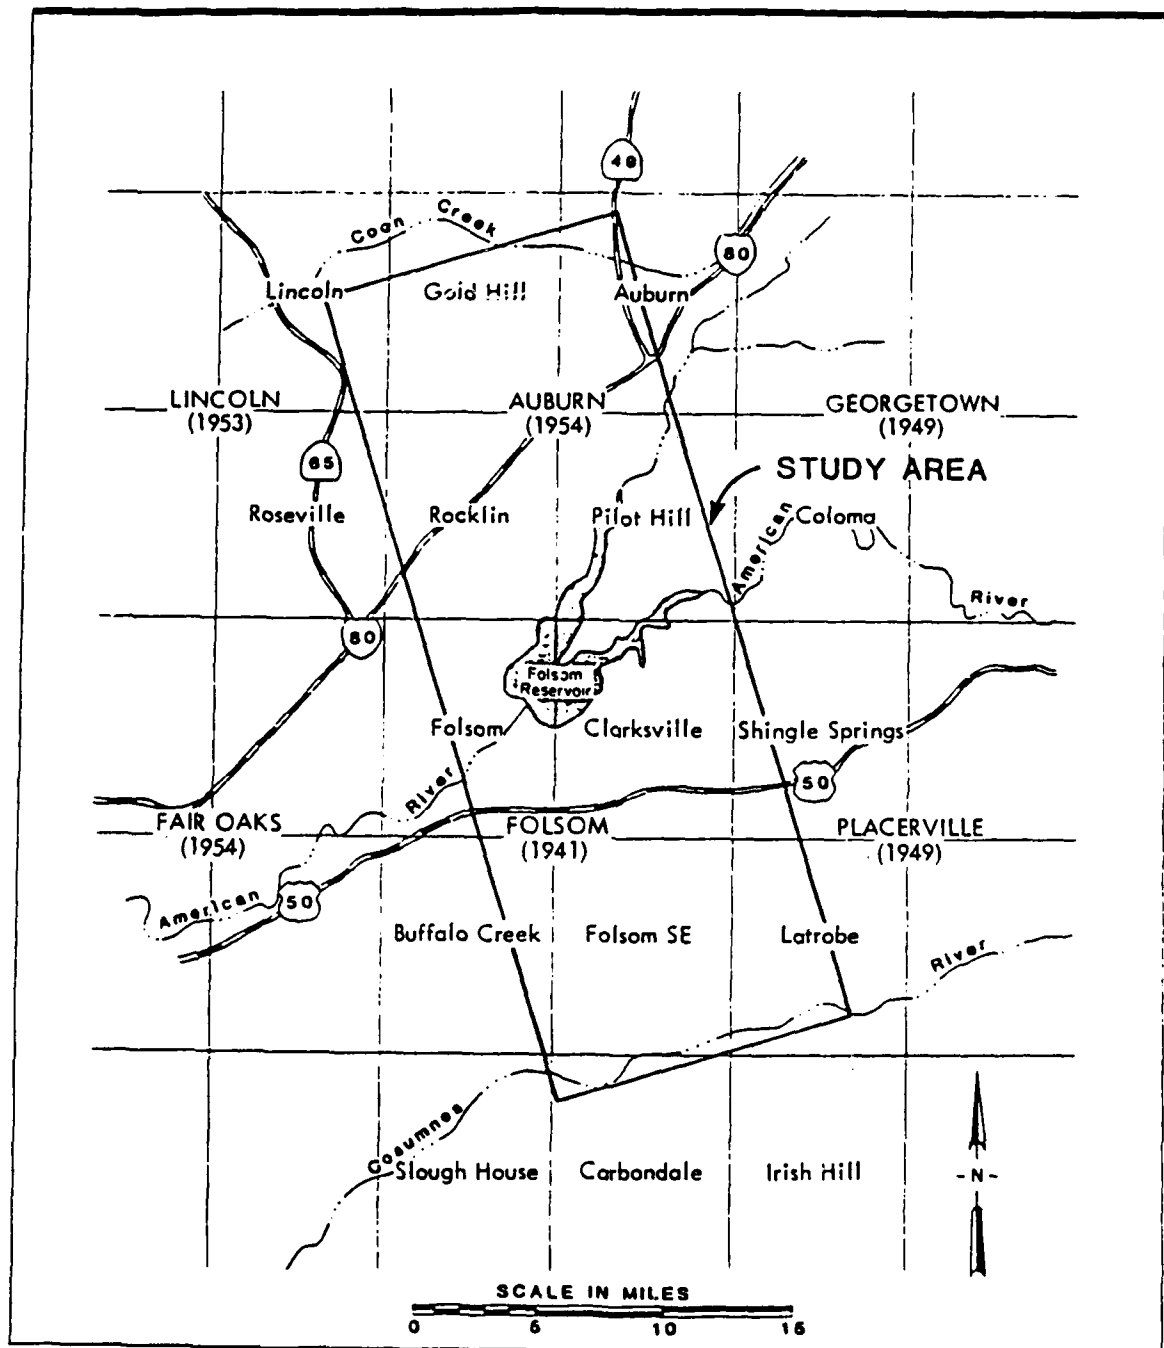
Figure 3. Close-up of study area

Prepared by Tierra Engineering Consultants

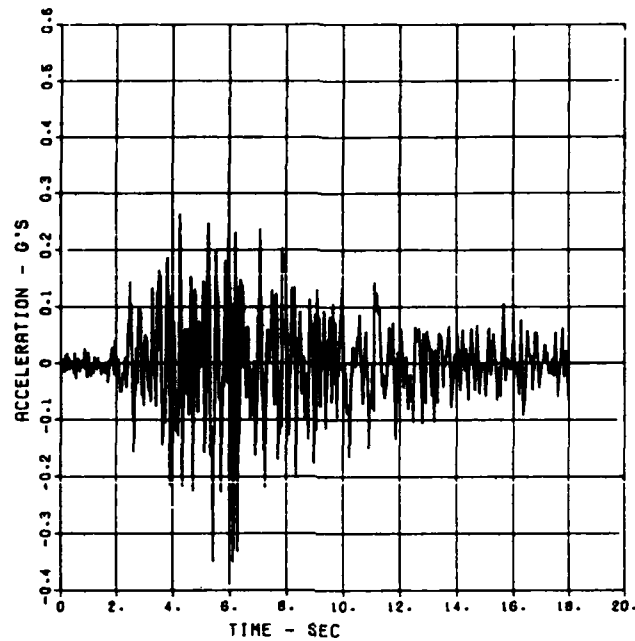
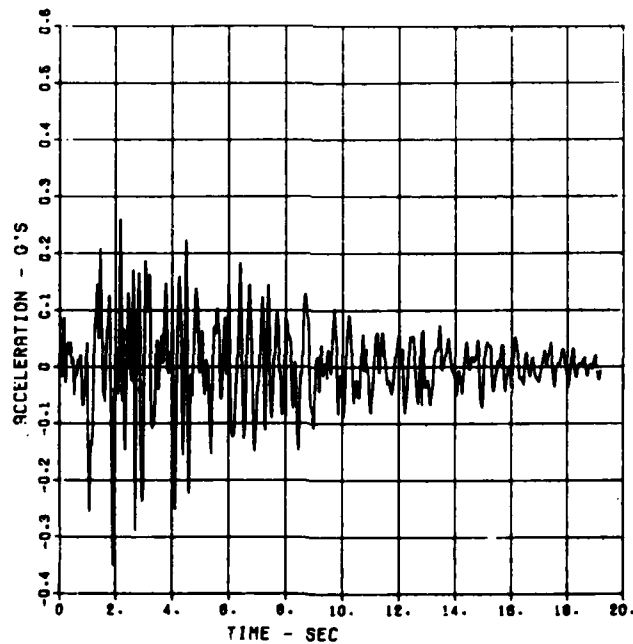
Figure 5. Design accelerograms

EQ1H
HORIZONTAL ACCEL HIST
08/11/87 90830 P1113.40

EQ2H
HORIZONTAL ACCEL HIST
08/11/87 90830 P1113.40

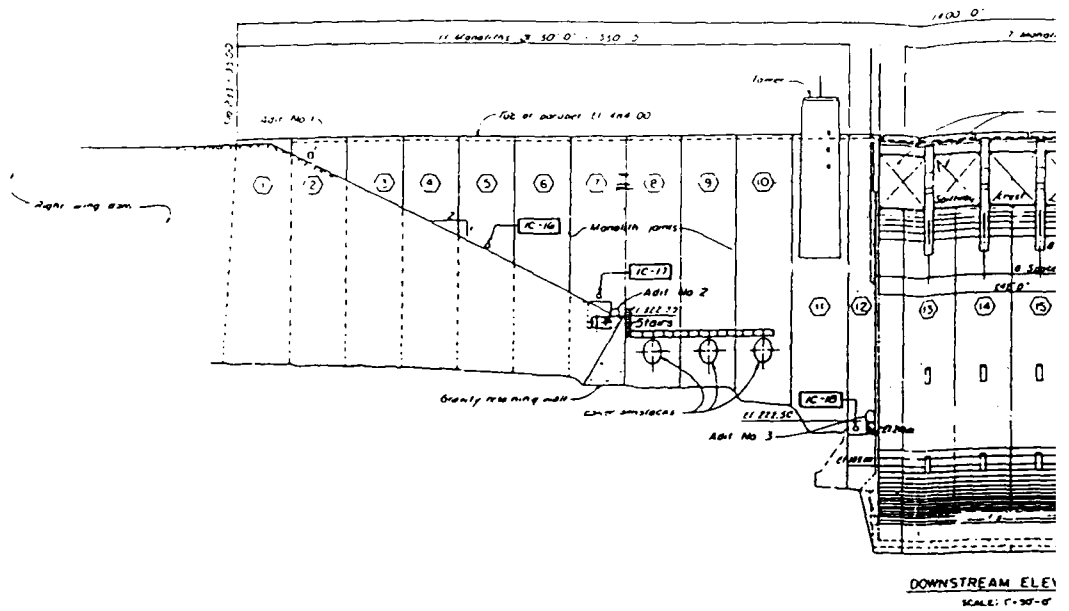
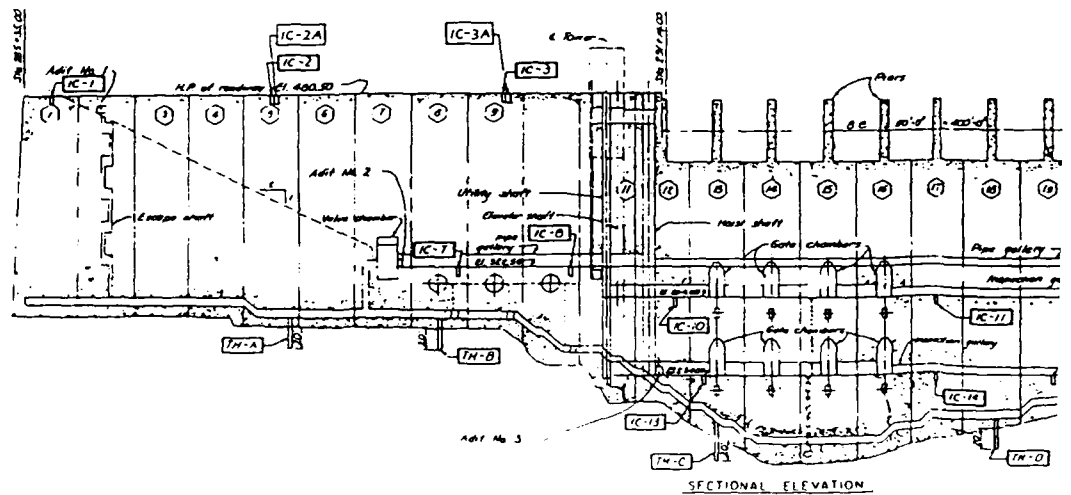
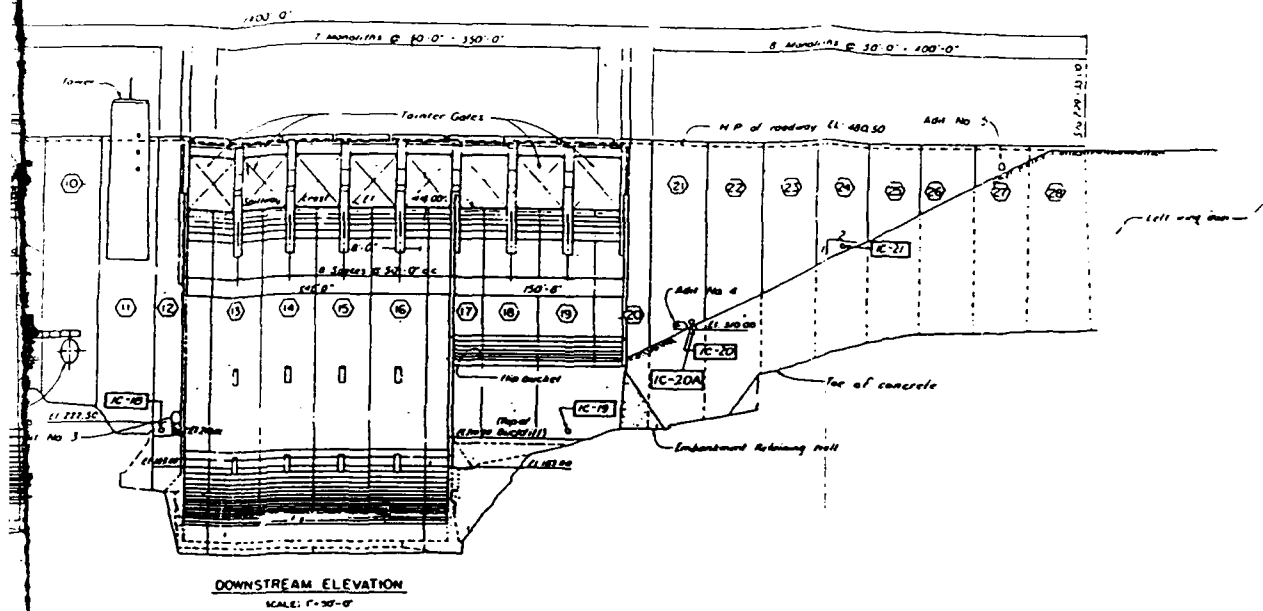
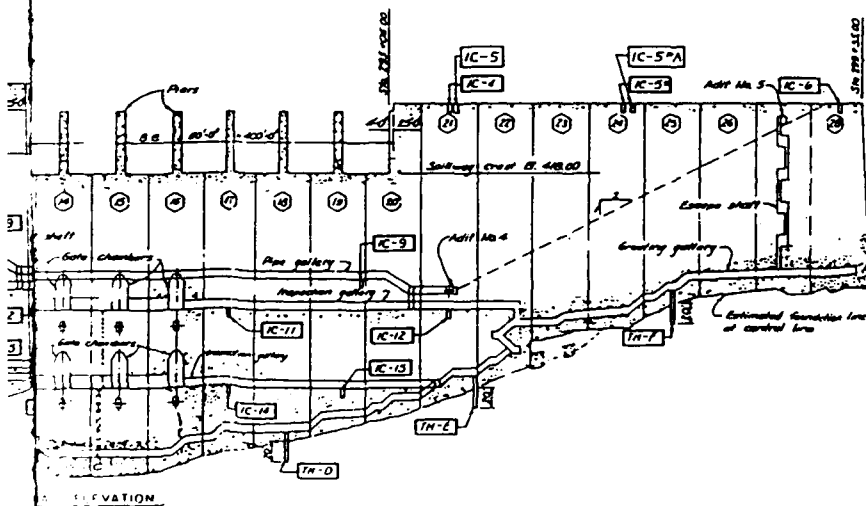
1. Concrete Core Drill Sites: IC-1 to IC-11
Downstream face
2. Concrete Core Drill Sites: IC-1 to IC-5
Galleries
3. Rock Core Drill Sites: TN-A to TN-F
Grout Gallery

fa core holes downstream face and sectional views

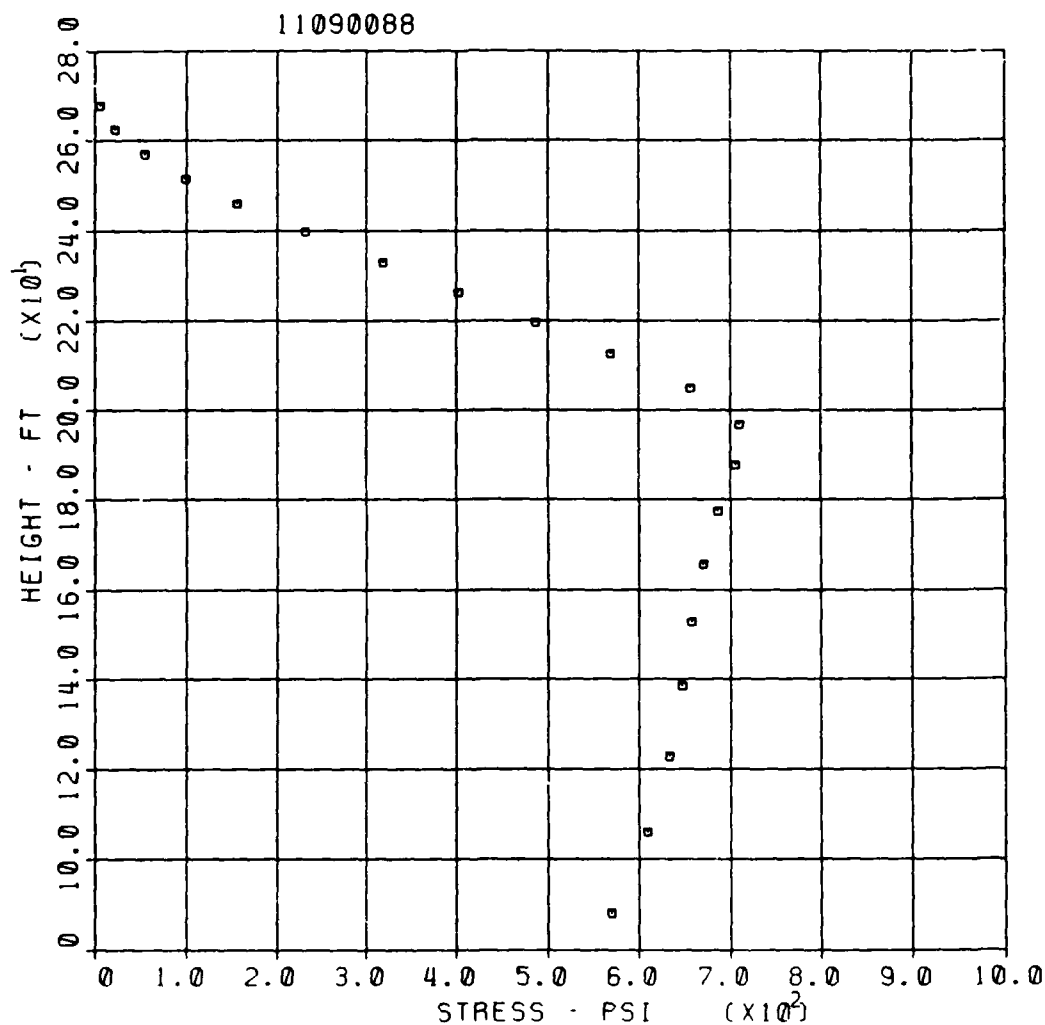
Figure 22. Heightwise distribution of envelope values of maximum principal stress along the upstream face for Case 3

EQ2 - HV, A = .82, ER = 11.0

SIGMA - 1 UPSTREAM

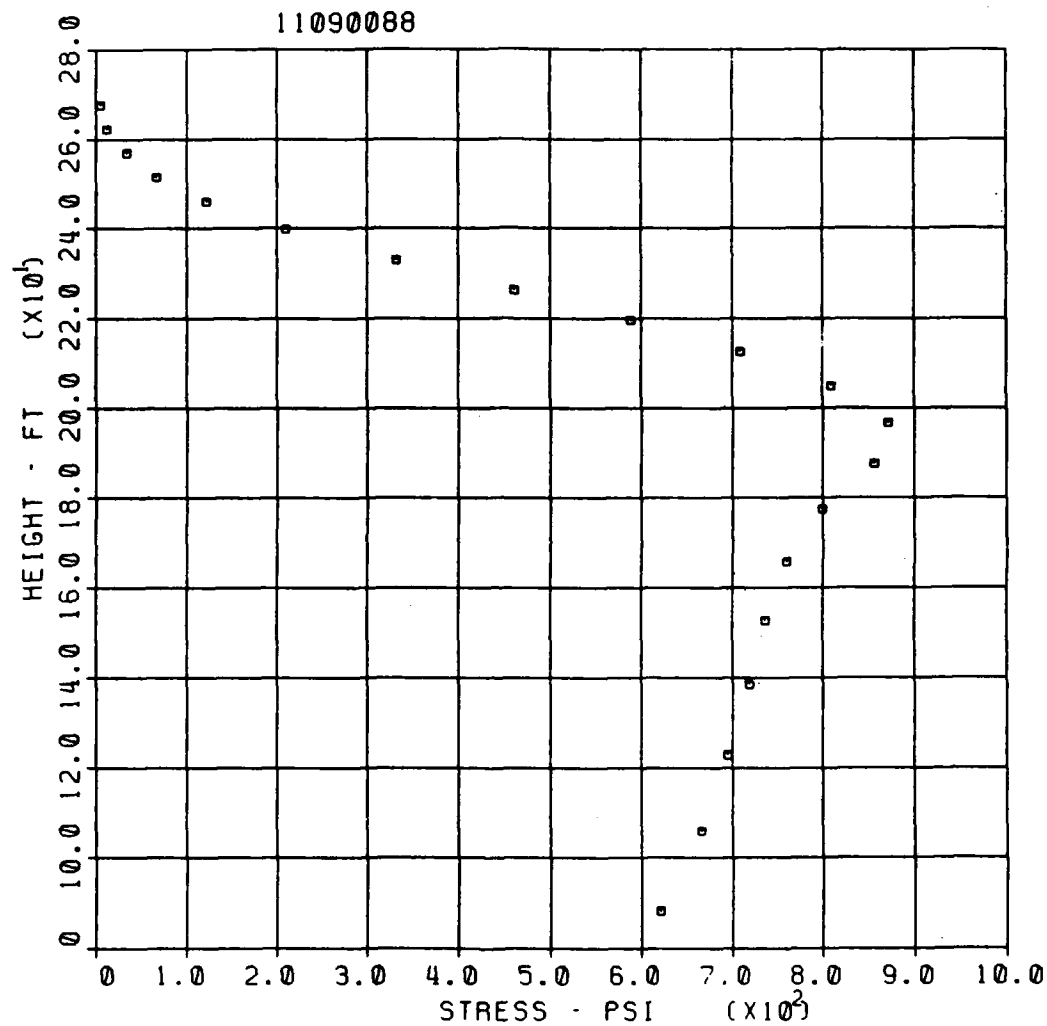
Figure 23. Heightwise distribution of envelope values
 of maximum principal stress along the
 downstream face for Case 3

EQ2 - HV, $A = .82$, $ER = 11.0$
 SIGMA - 1 DOWNSTREAM

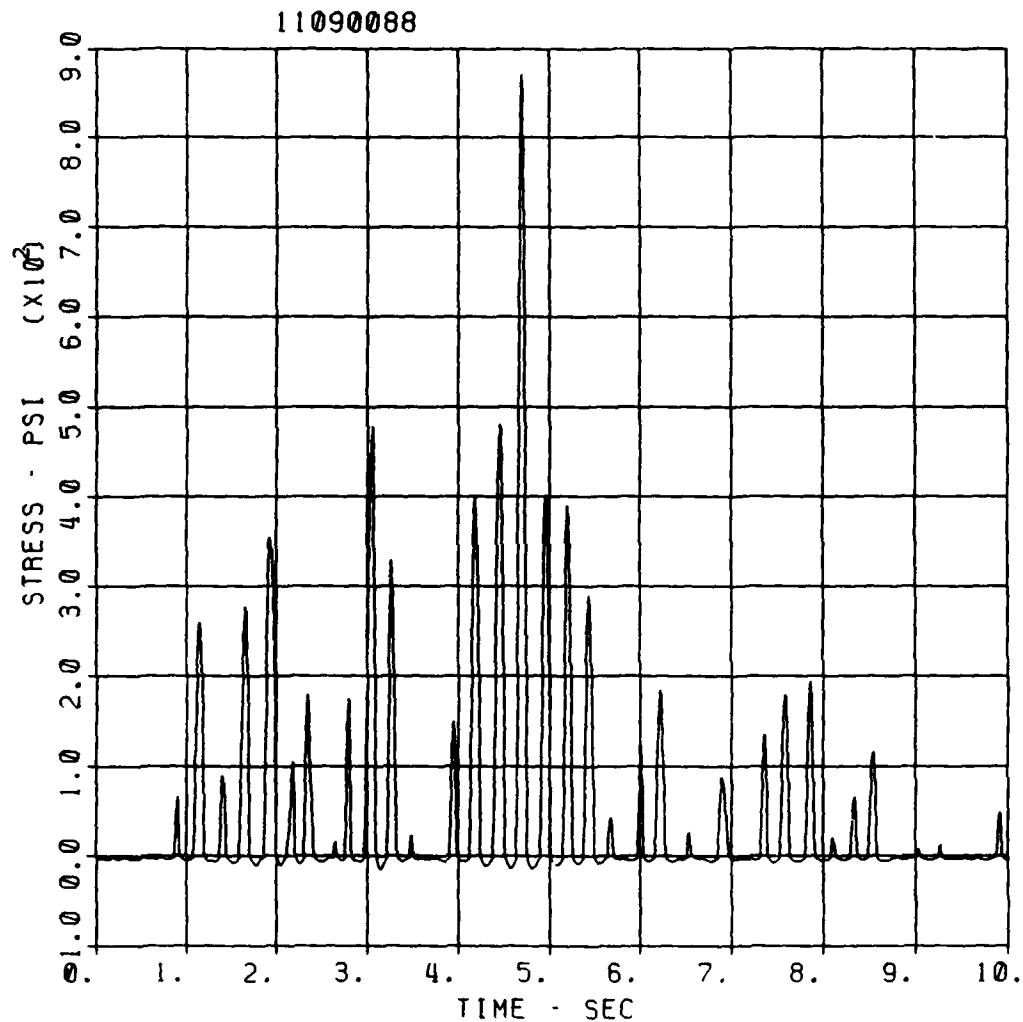
Figure 24. Maximum principal stress in element
120 for Case 3

EQ2 - HV, A = .82, ER = 11.0
SIGMA - 1 ELE NO. 120

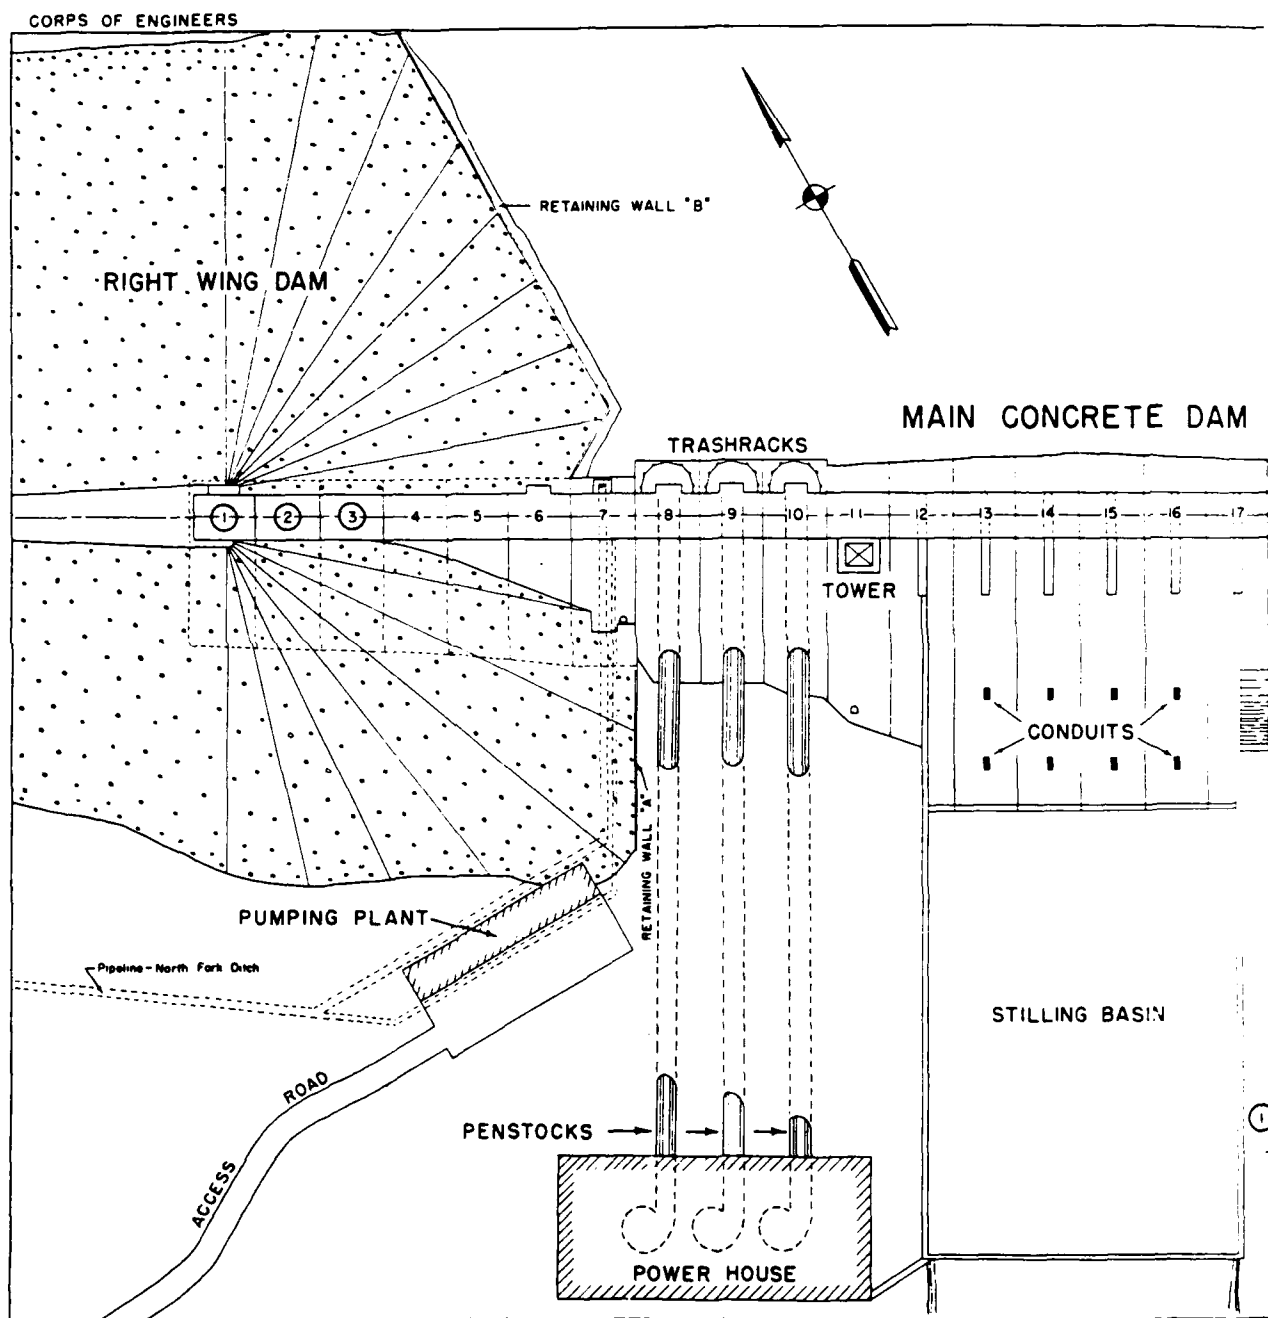
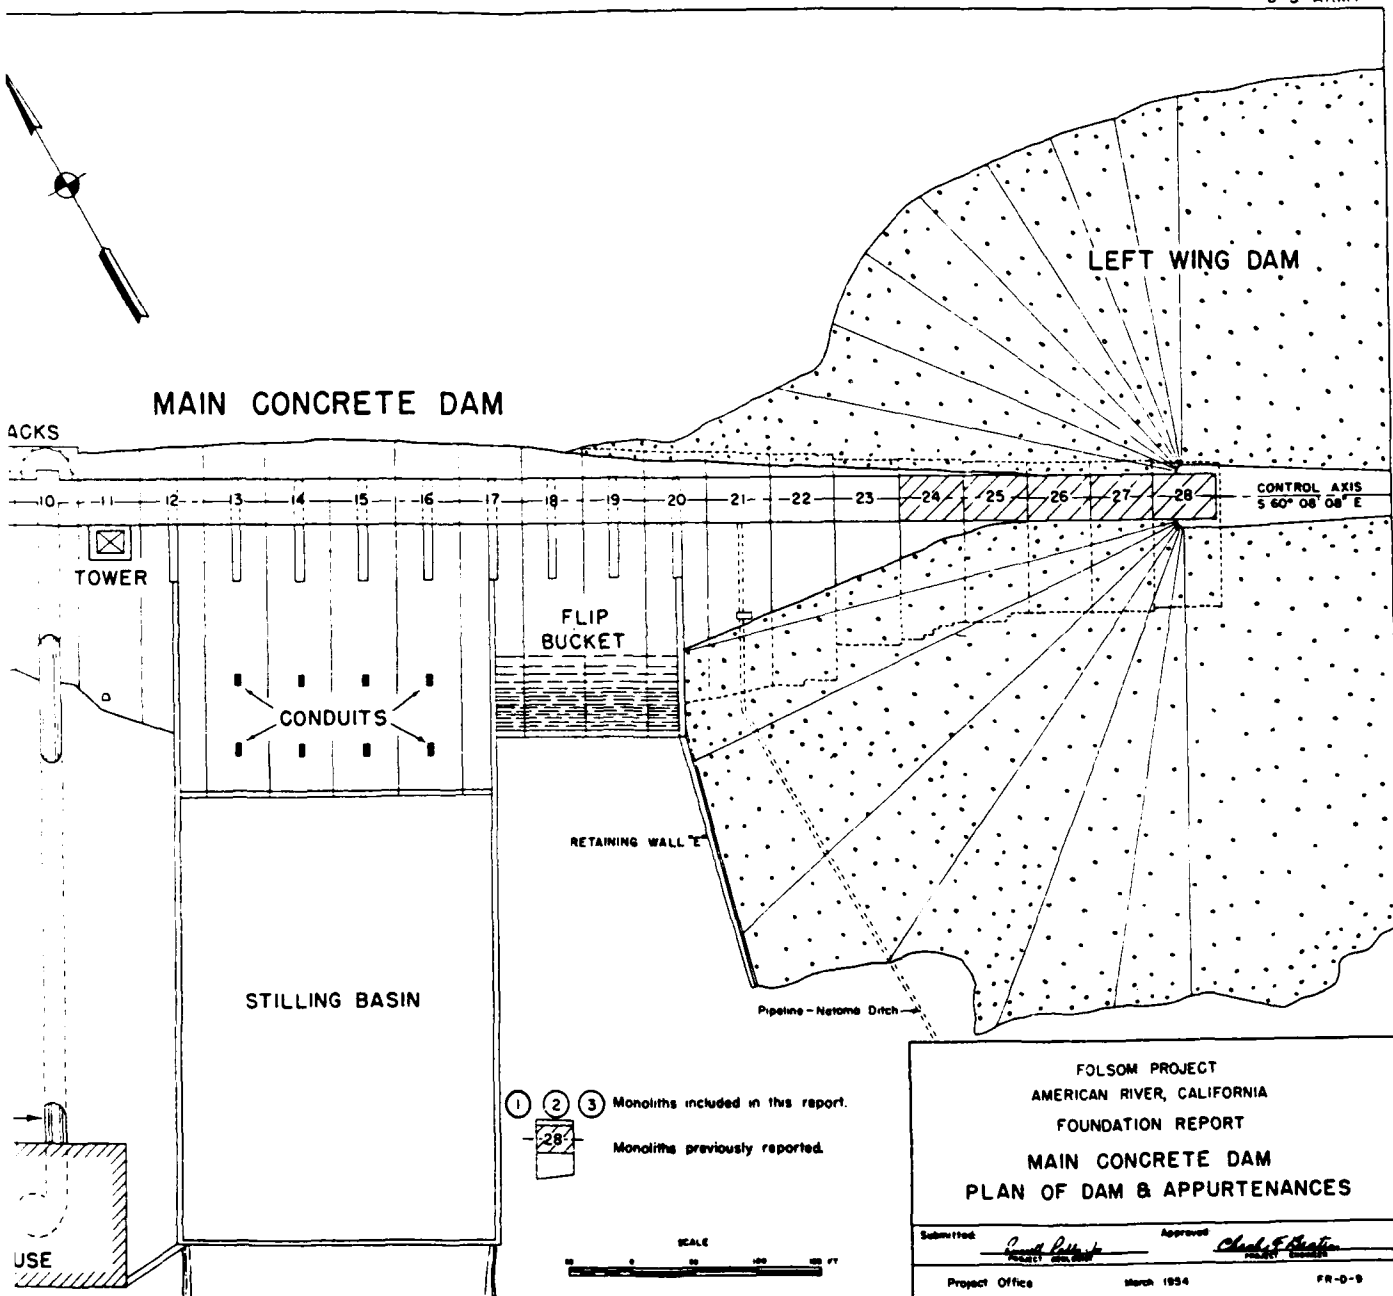
Figure 1. Plan View of Concrete Gravity Dam and Appurtenances

Plan of Concrete Gravity Dam and Appurtenances.

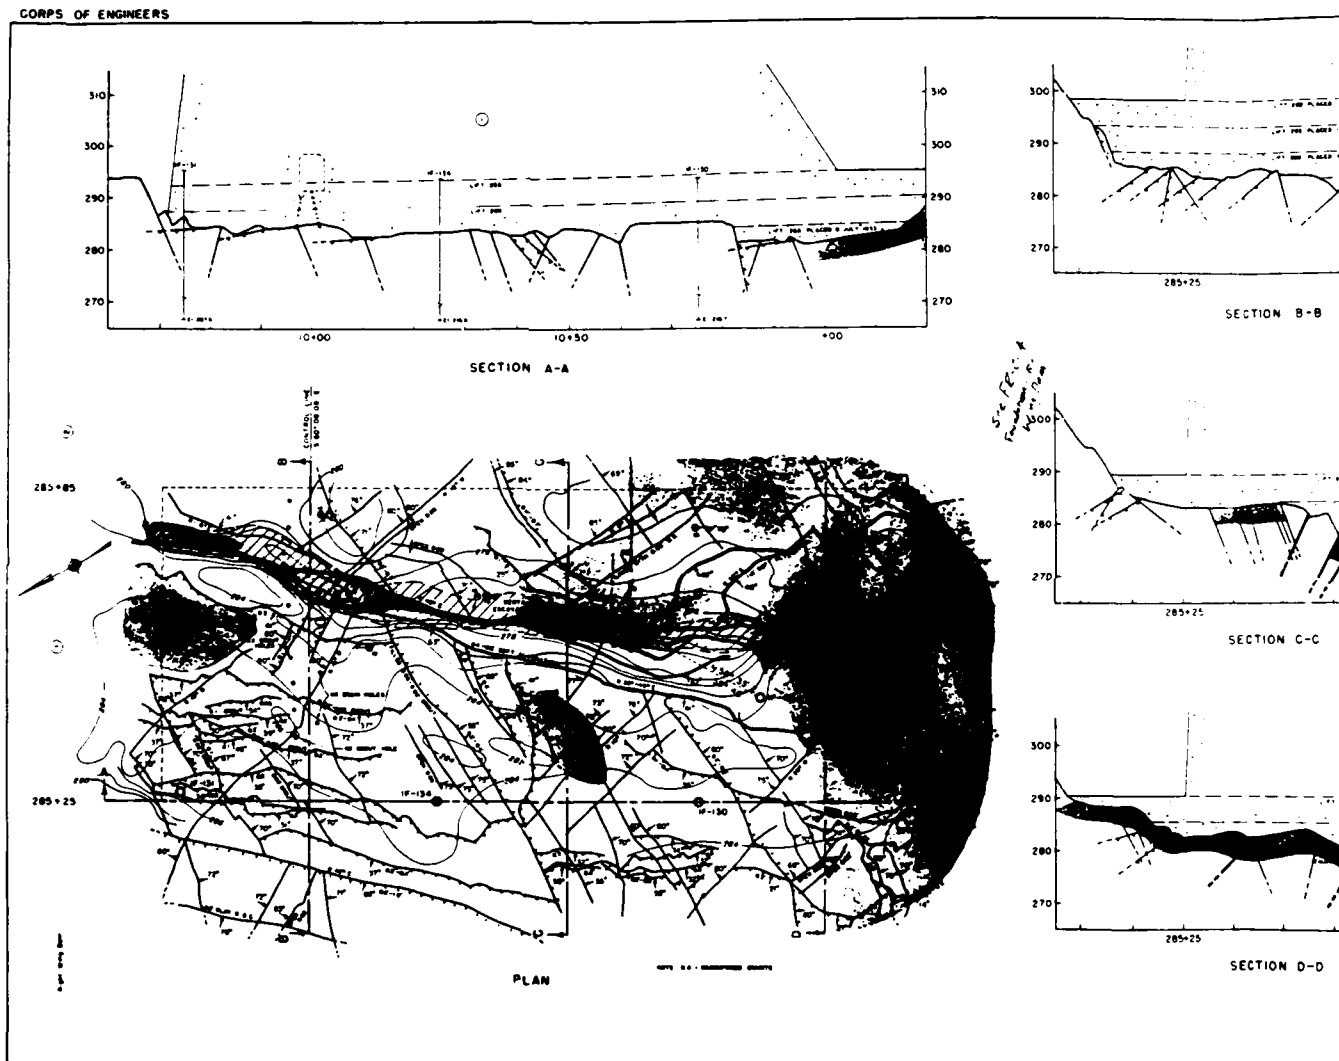
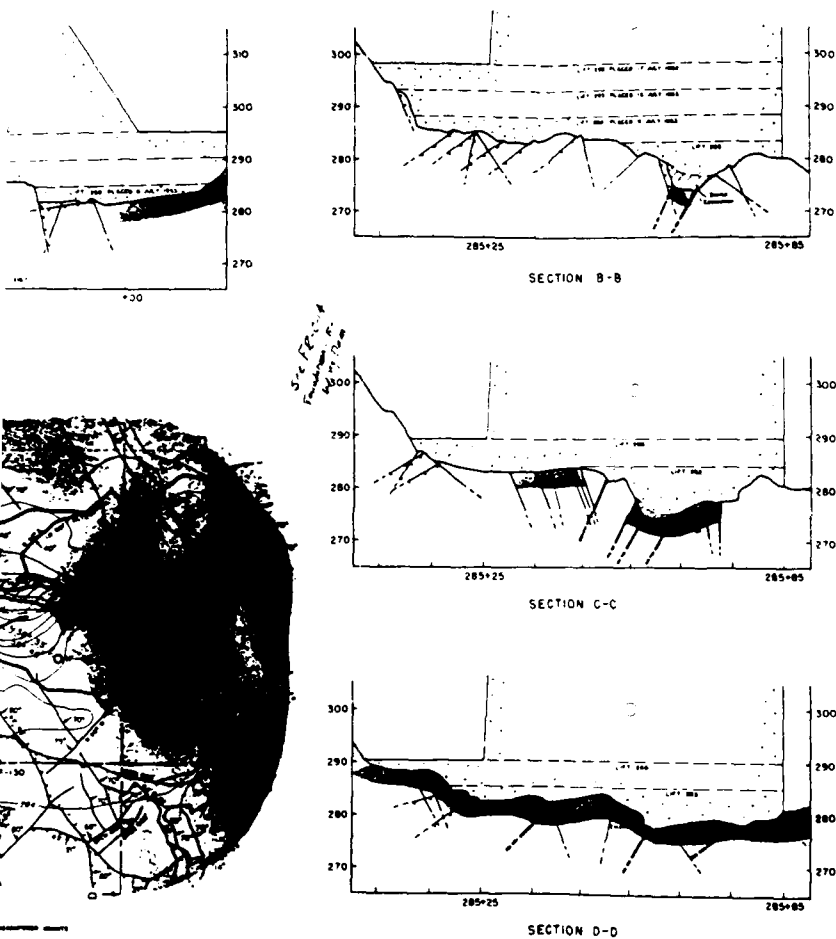
Figure 2. Plan and Sections of Concrete Gravity Dam Monolith 1.

- GRANITE (Quartz Dolerite). Slightly to moderately weathered
- GRANITE (Quartz Dolerite). Moderately to intensely weathered
- Trace and dip of joints B fault
- Right bank
- Fault
- Anticline joints striking N 40°-55° E. Small figures indicate elevation extent
- Faulted joints - generally strike N 75°-90° E. Small figures indicate extent of break extension
- NZ core drill hole, 2 1/2" core, vertical
- NZ core drill hole, 2 1/2" core, angle
- Location of photograph No 10

8. Trending through the foundation from NE to SW is a fault zone (strike N 45° E and dip 40° to 62° NW) which consists of a number of irregular branches and interconnectors with the presence of many joints. Due to the presence of extensive amounts of soft, intensely weathered granite on either side of the main branches of the fault, dental excavation was necessary. A V-shaped trench was excavated to reach improved rock. The trench was back-filled with concrete to prevent seepage along this path. Approximately 35 percent of the foundation surface beneath Monolith 1 is moderately to intensely weathered the remaining 65 percent is slightly to moderately weathered. The locations of all drill holes and the fault zone are shown in Figure 2.

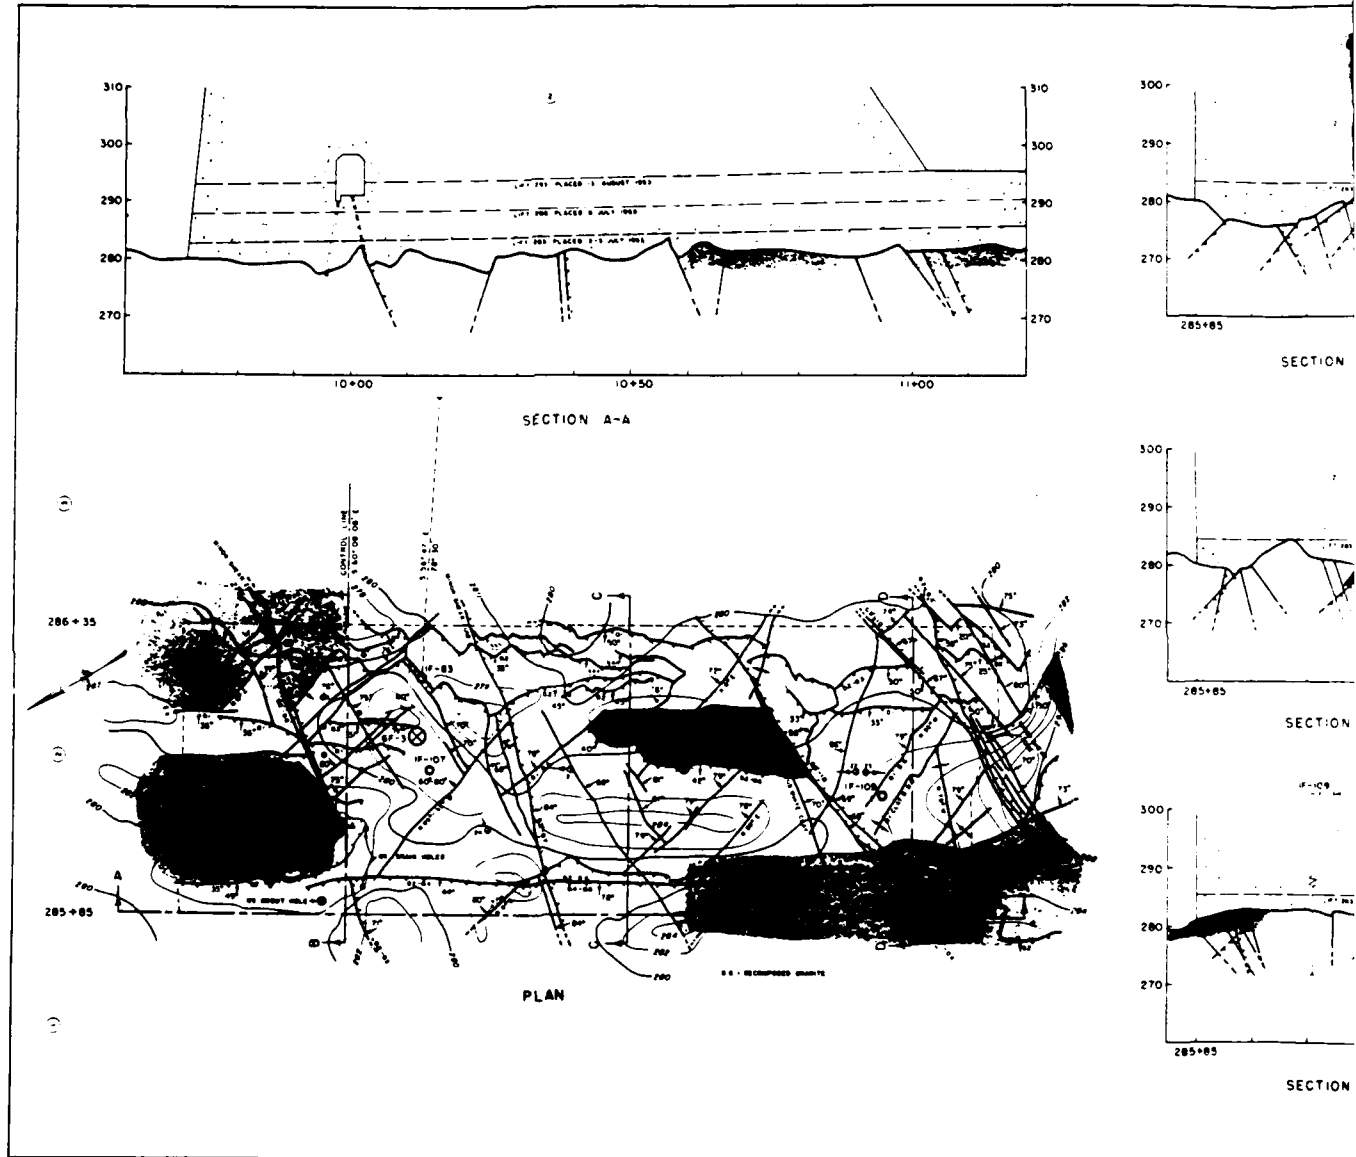
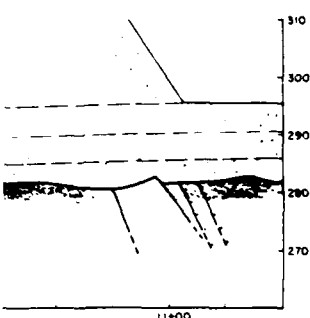
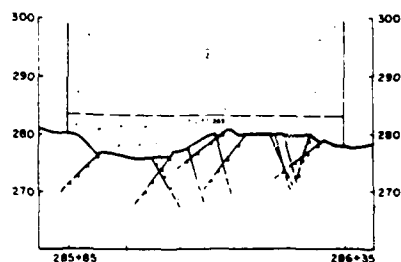
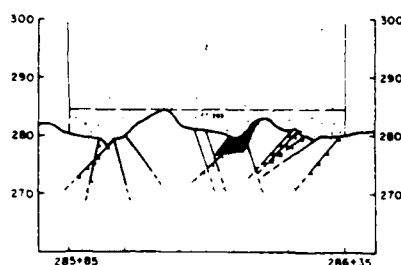
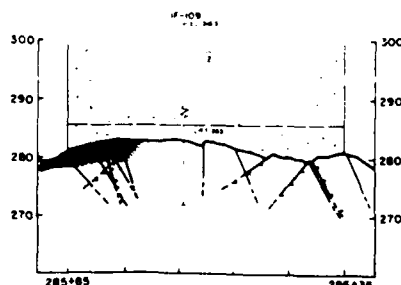
Figure 3. Plan and Sections of Concrete Gravity Dam Monolith

- GRANITE (Overly Quartz)** Slightly to moderately weathered
GRANITE (Overly Quartz) Moderately to intensely weathered
 Fault and dip of joints & shear zones
 Tight joint
 Altered joints striking N 40°-55° E. Small figures indicate alteration extent.
 Foliation-mapped joints-generally strike N 75°-90° E. Small figures indicate extent of linear foliation.
 NX cored drill hole, 2 1/2" core, vertical
 NX cored drill hole, 2 1/2" core, vertical
 Cally hole, 36" diameter
 Location of photograph No. 22

11. The foundation rock at the base of Monolith 2 consists largely (nearly 75 percent) of slightly to moderately weathered granite. The total area of moderately to intensely weathered granite encompasses 750 sq ft (total area of the foundation is 7,150 sq ft). The Calyx 6F-3 hole was backfilled with concrete before construction of the monolith began. The location of the three holes are shown in Figure 3. The foundation grade for Monolith 2 is founded at approximate el 281.

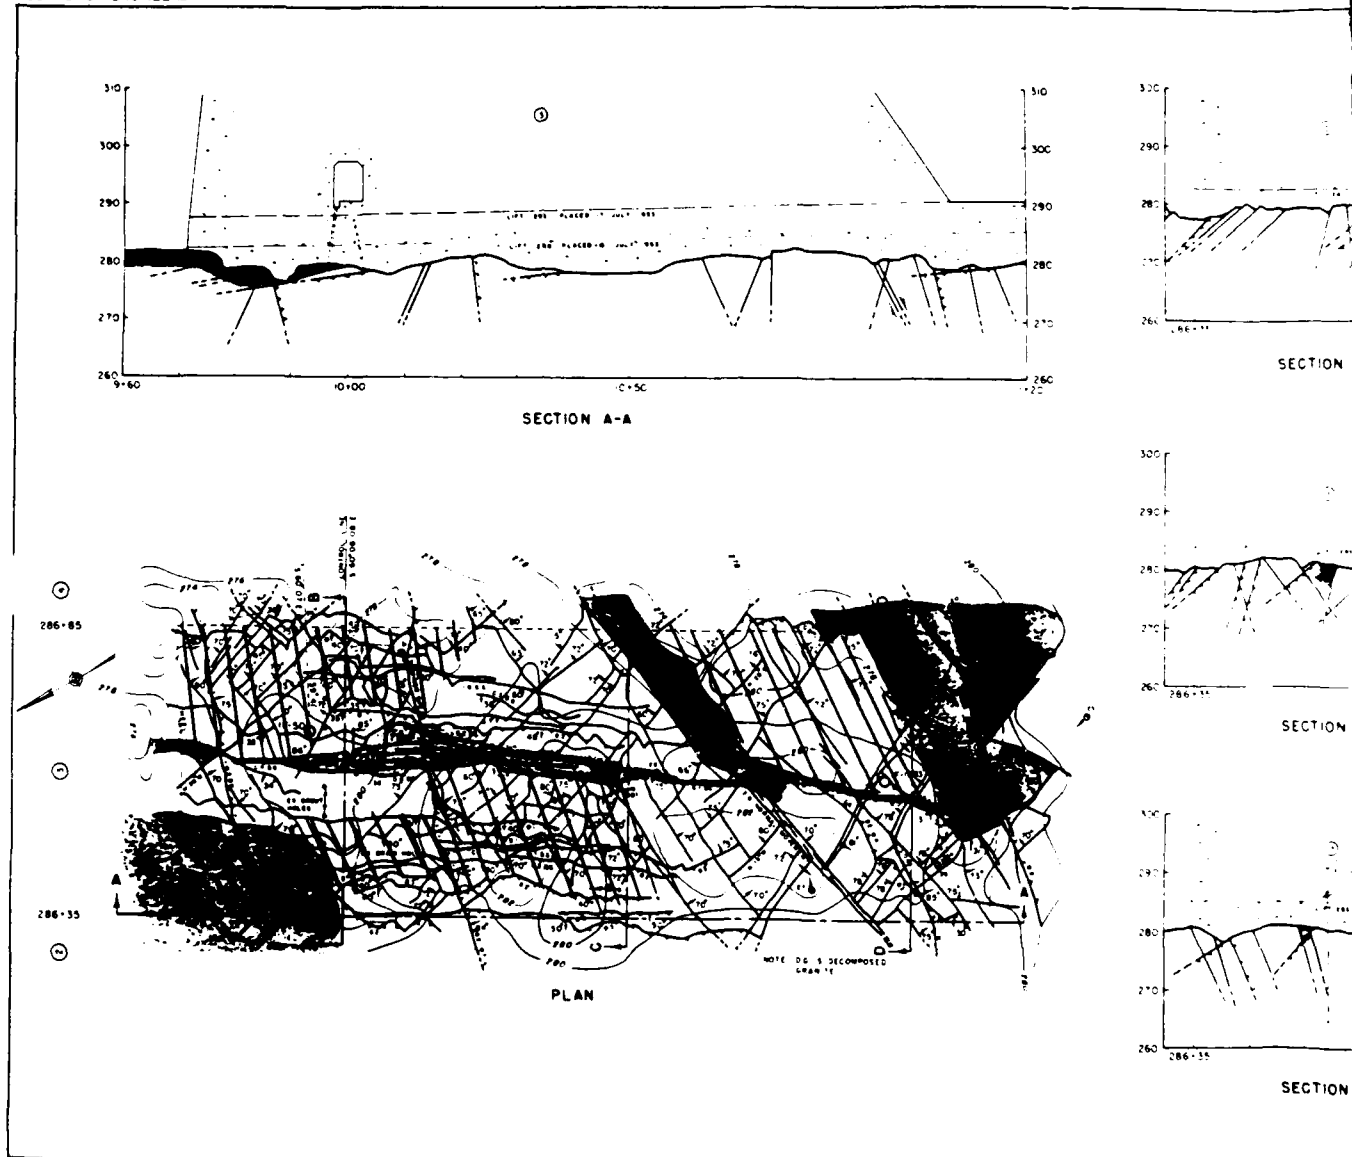
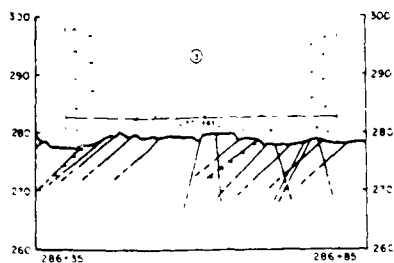
Figure 4. Plan and Sections of Concrete Gravity Dam Monolith

SECTION B-B

12. Monolith 3 is 143 ft long at its base and rises approximately 200 ft above its foundation. Two holes were drilled in the foundation for Monolith 3. They are designated 1F-50 (drilled before any excavation and at an angle of 59°41') and 1F-111 (drilled after some excavation). The drill hole locations are shown in Figure 4. Hole 1F-50 was located approximately 8 ft upstream of the control line and penetrated to el 227.0. From the surface to el 280.9 intensely and highly weathered granite was encountered. Below this elevation the granite was sound and the joints were tightly filled with argillaceous material. Hole 1F-111 bottomed at el 264.3. Sound granite predominated below el 300.5. Closely spaced jointing was the most notable structural feature of the Monolith 3 foundation. Granite which ranged from

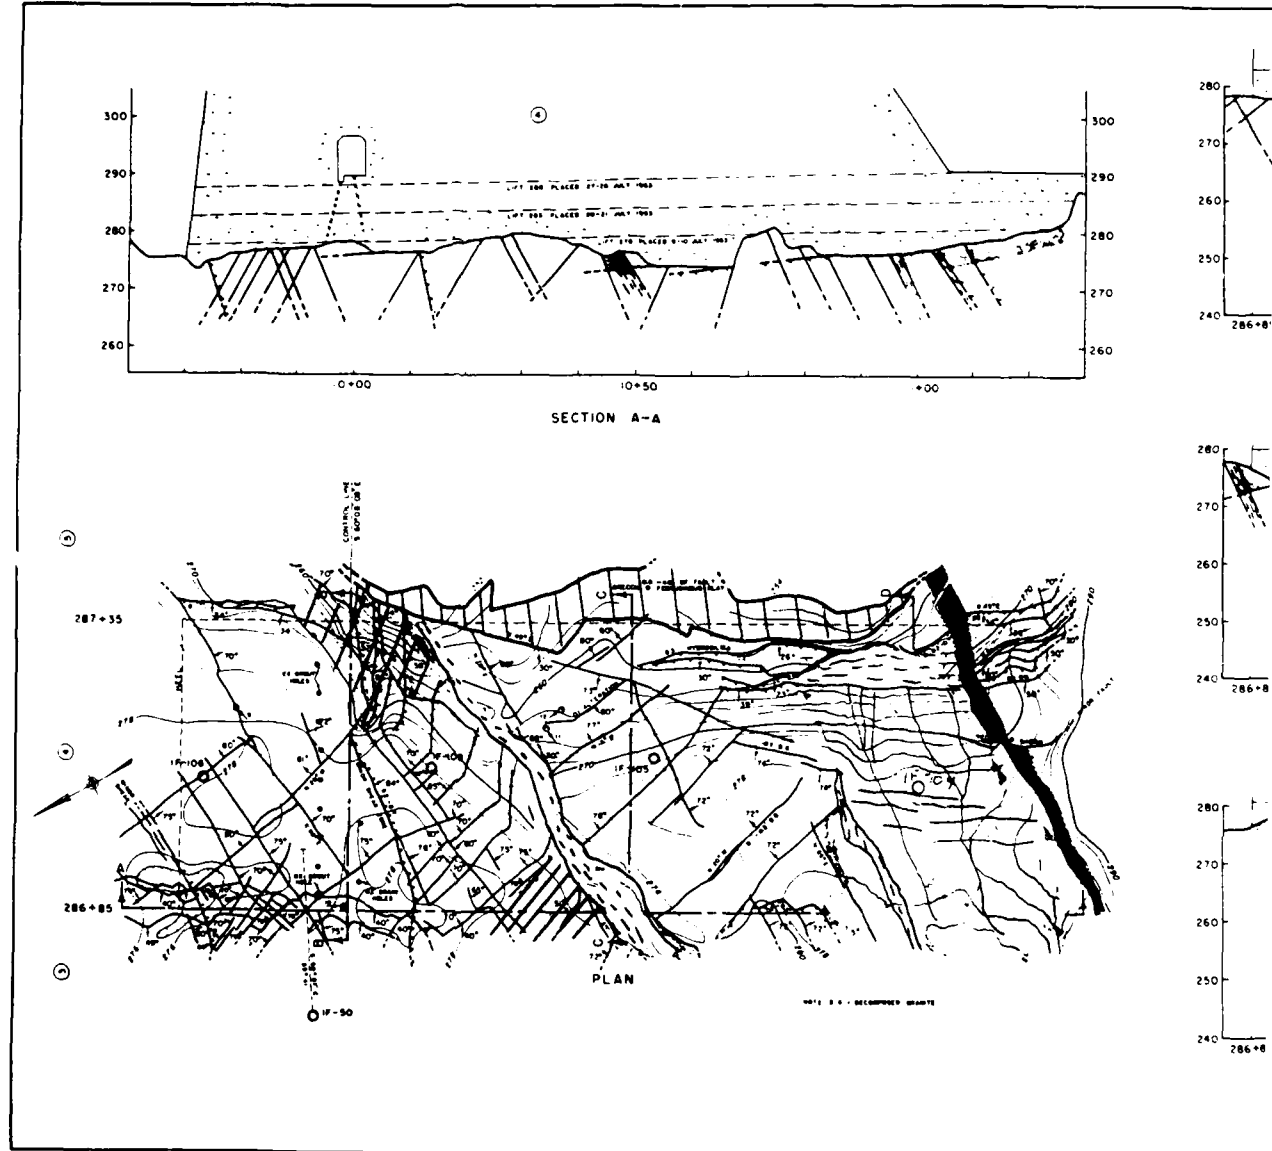
Figure 5. Plan and Sections of Concrete Gravity Dam

Sections of Concrete Gravity Dam Monolith 3.

zone up to 2 ft wide. A microdiorite dike, shown in Figure 5, was encountered trending across the foundation beneath the Monoliths 4-5 joint.
